Manhole Inspection Summary

Manhole # S29K__065MH

Insp Date: **1/30/09 10:58 AM**

Location Address: **762 Otterbein St.**

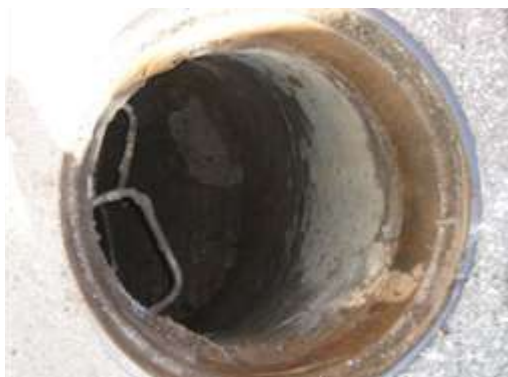
Misc

Frame view

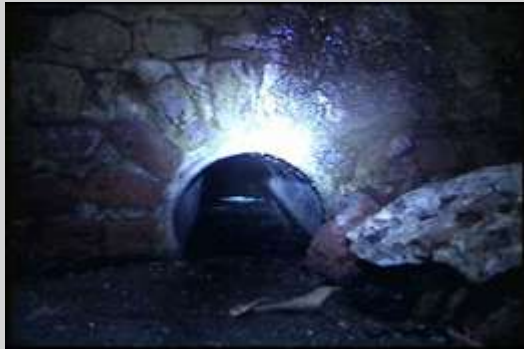
12 O'Clock Outflow

8 in. Circular Gravity Sewer
Pipe Out @ 12 O'Clock

Pipe Height: **8.4** (in.) Rod and Bar (Angled)

Pipe Material: **Clay** ☐ Pipe Lined

Infiltration: **None** Pipe Seal Cond: **Sound**
